FIRST ANNUAL MONITORING REPORT
for the
ALTA LA JOLLA DRIVE
DRAINAGE REPAIR PROJECT, PHASE 2

(ACOE 404 SPL-2010-00157-RRS; CDFW SAA #1600-2010-0053-R5; RWQCB 401 #10C-033)

DECEMBER 2017

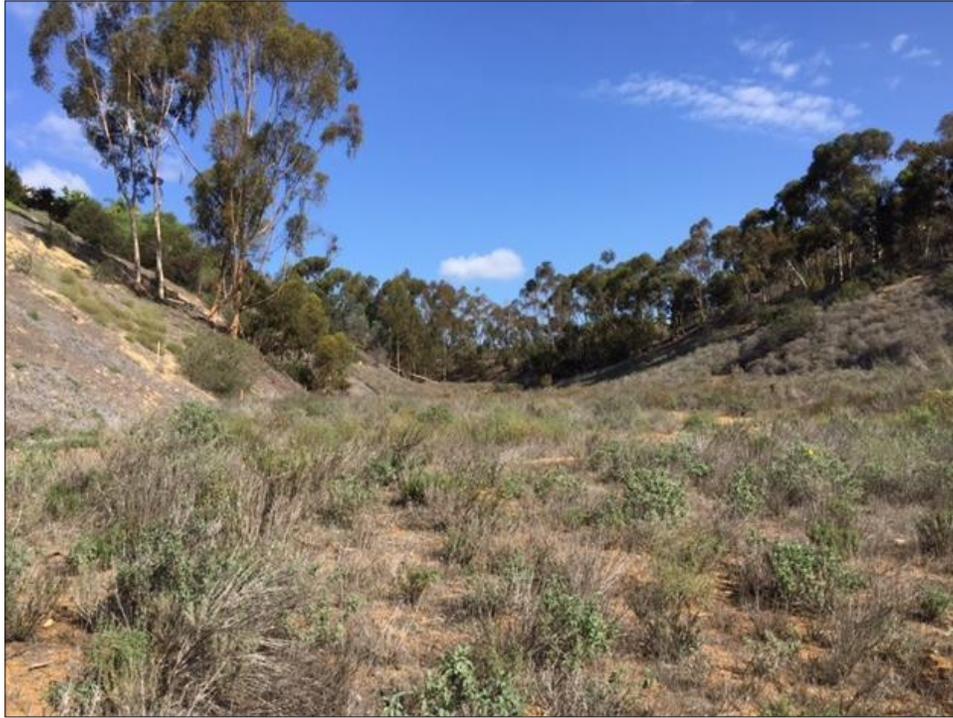
PRE-PROJECT

Photo Point 1: View north at future energy dissipater location. (October 20, 2015)

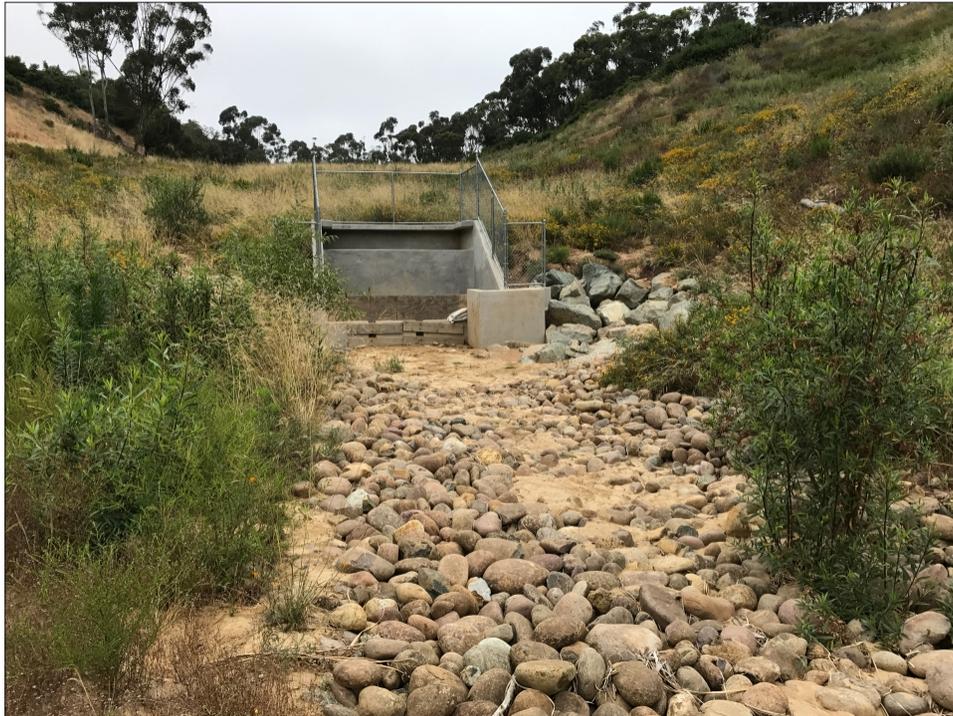
POST-PROJECT

Photo Point 1: View north at energy dissipater location. (June 2, 2017)

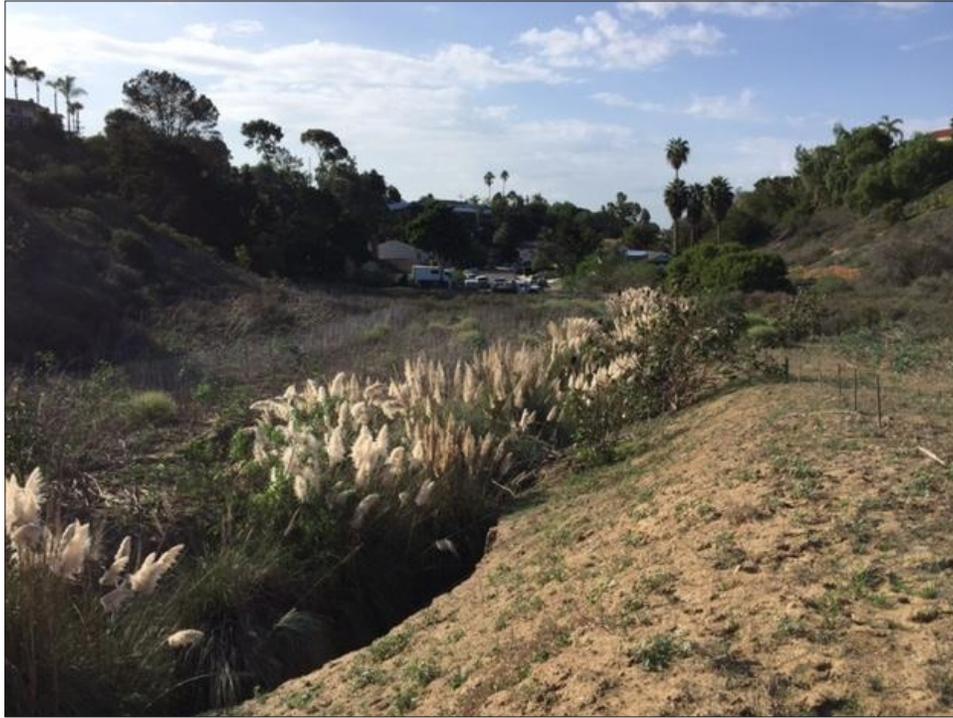
PRE-PROJECT

Photo Point 2: View south of future detention basin location. (October 20, 2015)

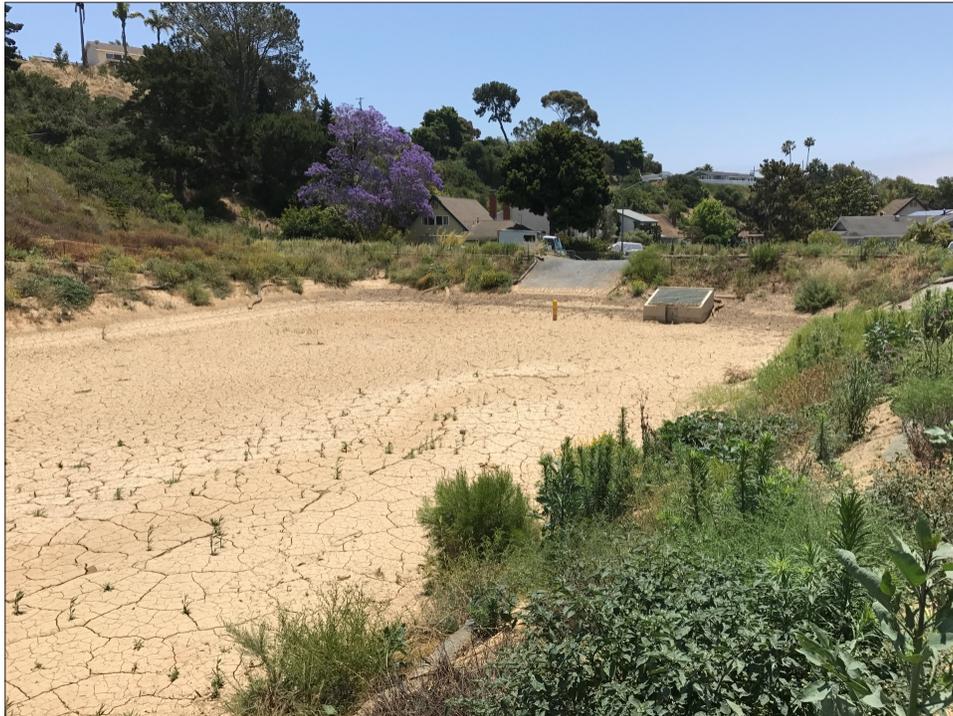
POST-PROJECT

The detention basin was monitored closely during the first year. This area was slow to establish due to the fact that it was seeded in the summer and was unirrigated. The frequent rainfall in late 2016 and early 2017 hastened vegetation growth and establishment, and the basin met the 120-

day success criteria of 50% native cover in February. The detention basin is currently exhibiting 50–80% (Classes 5–6) vegetative cover, with an average of about 70%. Therefore, the average current conditions of the detention basin are not meeting the first year success criteria of 80% total cover. However, in accordance with the mitigation and monitoring plan (CMMP; Rocks Biological Consulting, 2015), City maintenance crews perform periodic pruning and removal of vegetation as well as dredging activities in order to allow drainage and functioning of the basin. Vegetative cover will consistently fall below the success criteria due to this periodic removal and trimming of vegetation. Despite the fact that the detention basin is not meeting first year success criteria, it is still performing the target functions of the basin.

Photo Point 2: View south of detention basin location. (June 2, 2017)

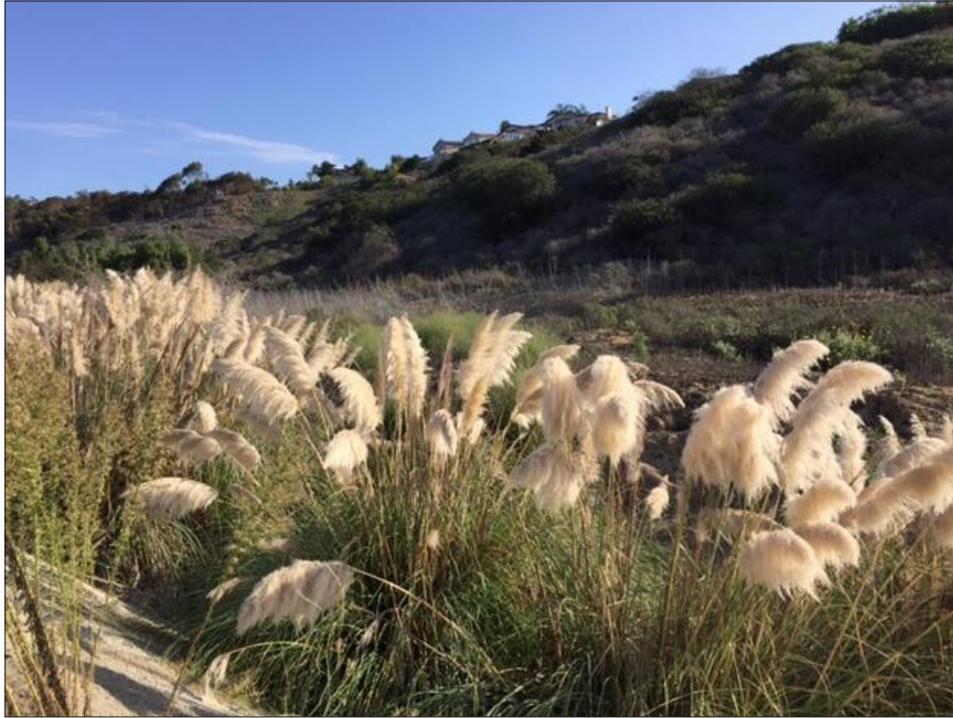
PRE-PROJECT
Photo Point 3: View northeast of future outlet to detention basin location.
(October 20, 2015)

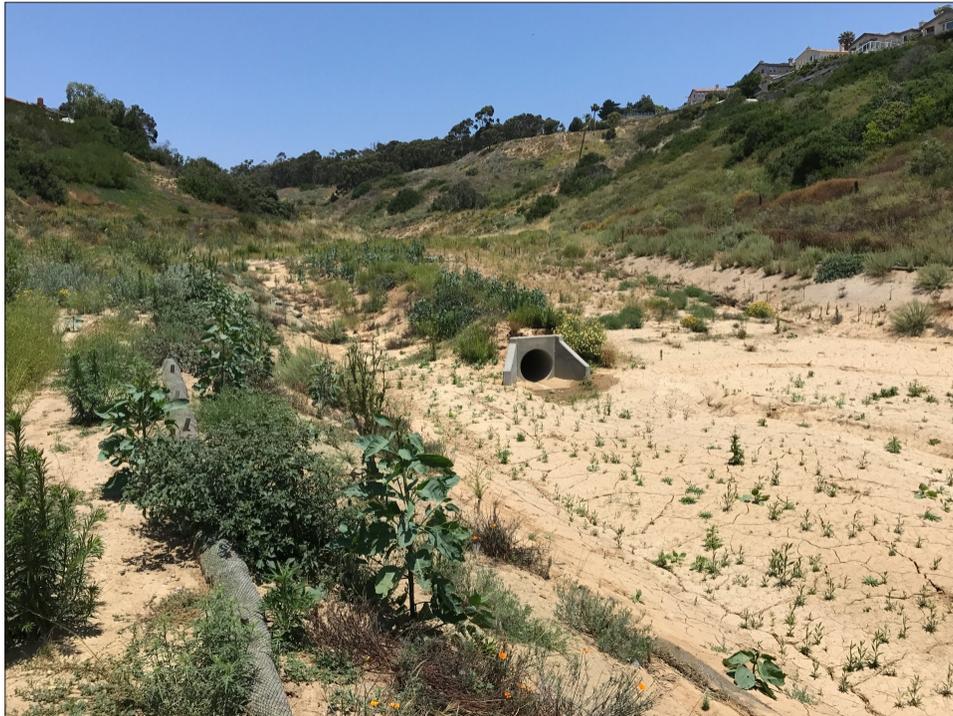
POST-PROJECT
Photo Point 3: View northeast of outlet to detention basin location.
(June 2, 2017)

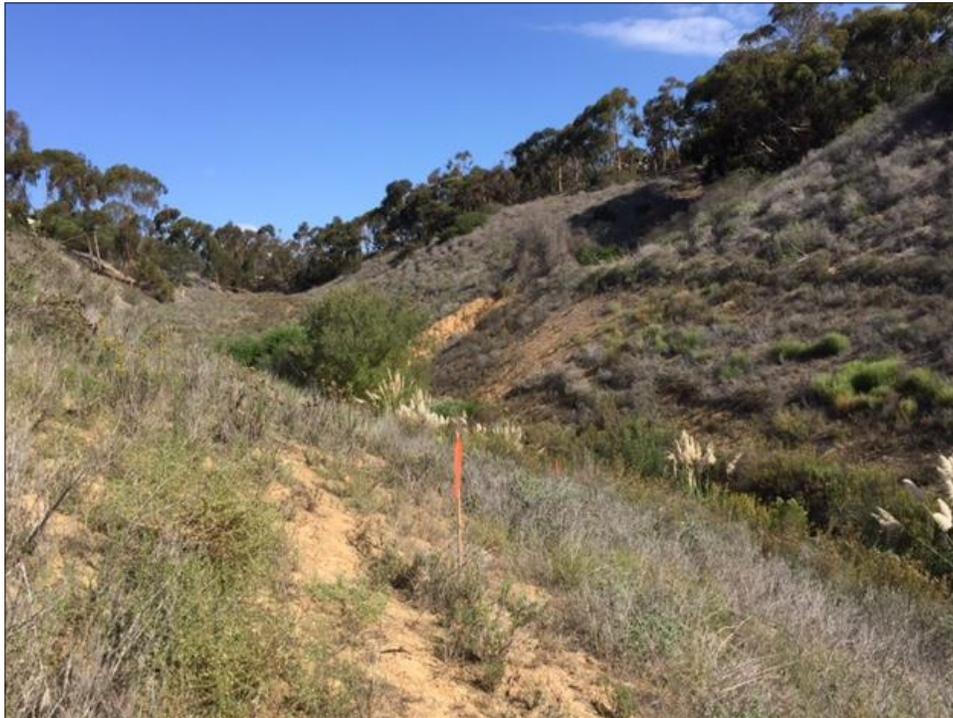
PRE-PROJECT

Photo Point 4: View north towards deep incision on eastern slope. (October 20, 2015)

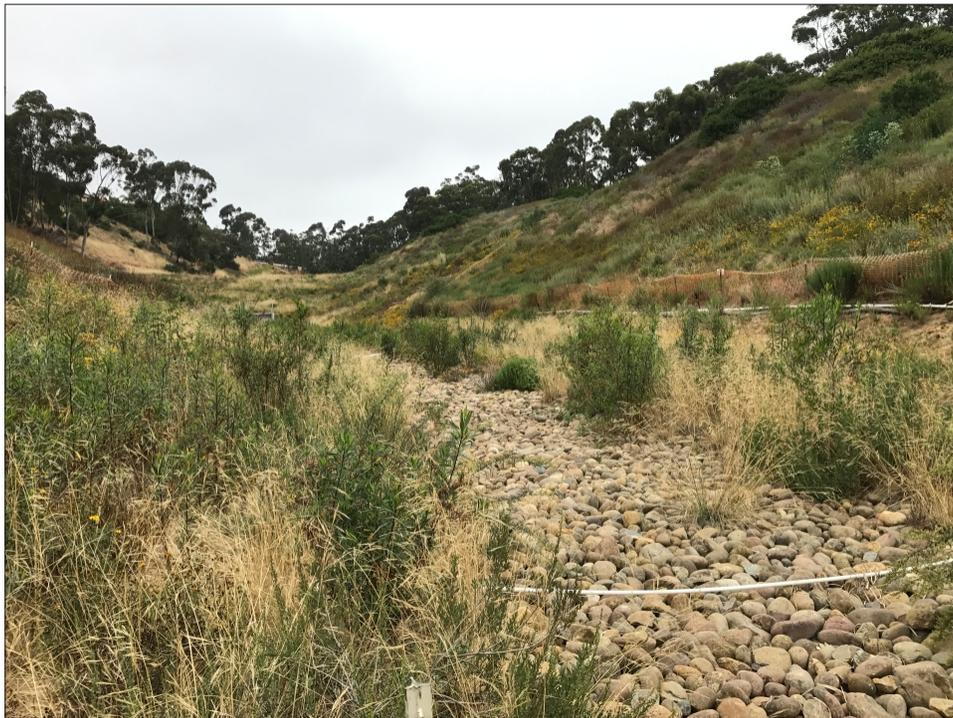
POST-PROJECT

Photo Point 4: View north after removal of deep incision on eastern slope. (June 2, 2017)

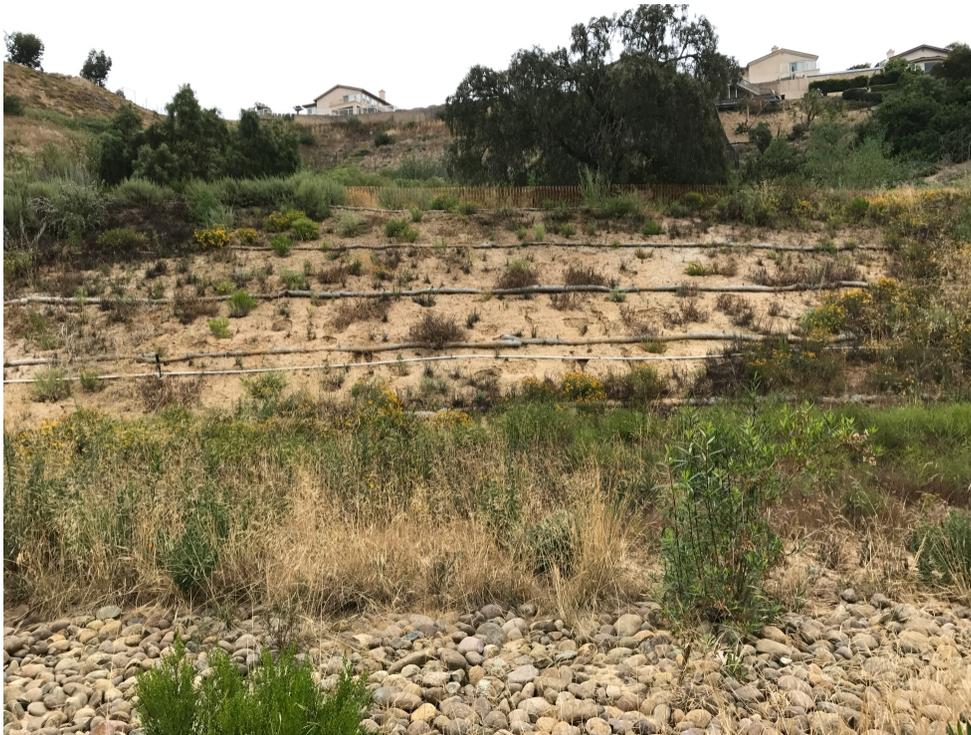
POST-PROJECT
Photo Point 5: View looking east at eastern slope. (June 2, 2017)

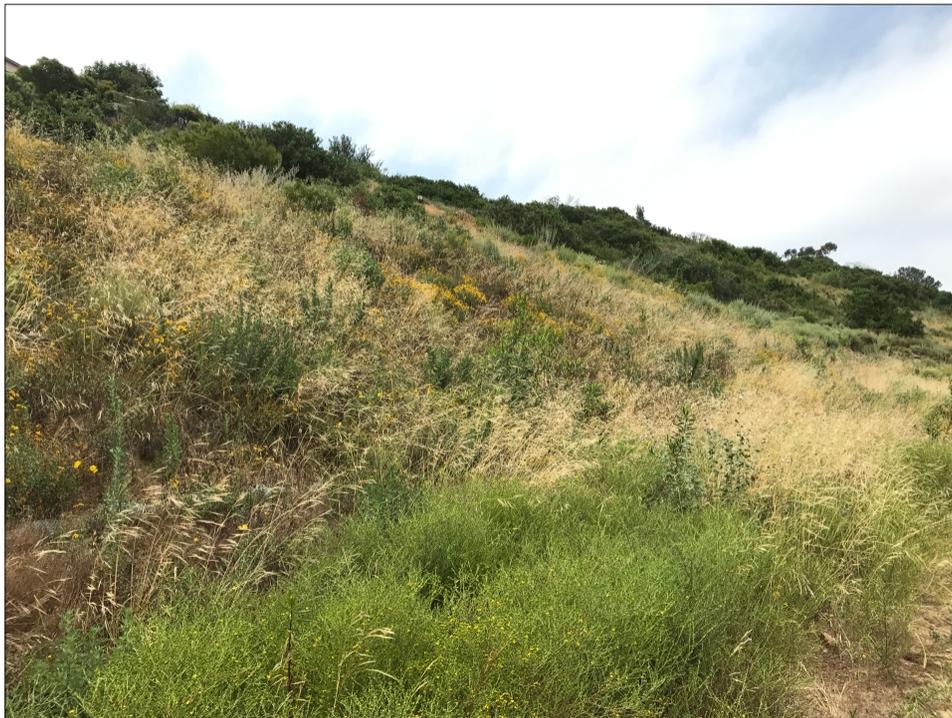
POST-PROJECT
Photo Point 6: View looking southeast at eastern slope. (June 2, 2017)
